**FLEET MOORING
UNDERWATER INSPECTION REPORT
LA MADDALENA, ITALY**

FPO 1-81 (24)
DECEMBER 81

OCEAN ENGINEERING
AND CONSTRUCTION PROJECT OFFICE
CHESAPEAKE DIVISION
NAVAL FACILITIES ENGINEERING COMMAND
WASHINGTON, DC 20374

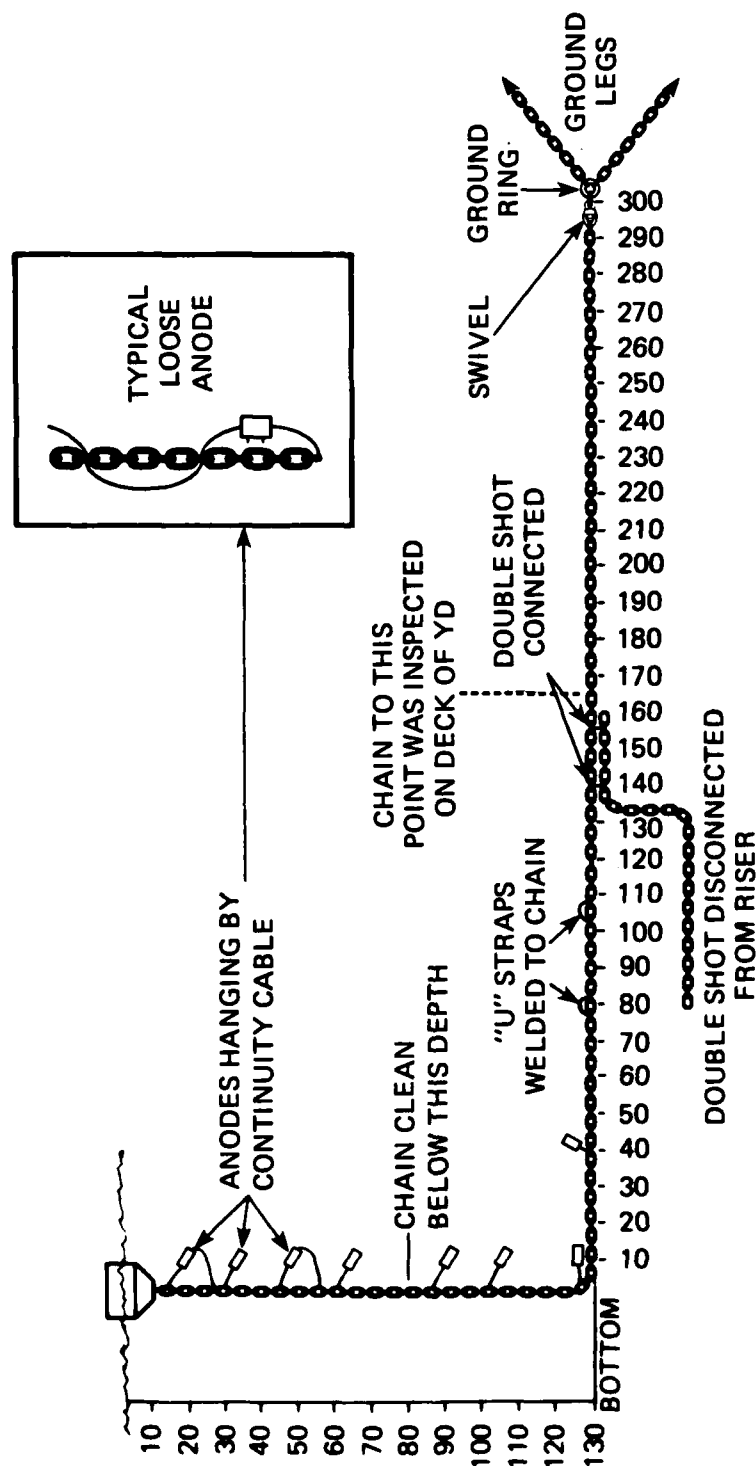
Figure A-11-1. North Bow Mooring Schematic After Removal of Twenty Links
(Not to Scale)

1.3.4 Cathodic Protection System. This system was in poor condition. Most anode mounting brackets had broken loose from the chain links, and many anodes were dangling from the riser chain by the wire rope continuity cable. In general, contact between the continuity cable and the chain was poor, and the continuity cable was broken in numerous places along the length of the riser chain.

1.3.5 Double Shot Sinker. Over two thirds of the shot of chain, originally designed to act as a sinker, had broken away from the riser. Only the lower 25-28 feet were attached by "U" straps. In this configuration, most of the double shot rested on the bottom and provided little added weight to the riser and thus, little capability as a sinker.

1.4 Conclusions and Recommendations. In general, this mooring appears to be in satisfactory condition. However, the cathodic protection system and double shot sinker are in need of repair, and the internal condition of those links to which anode studs were welded is questionable. It is recommended that the design of this mooring be reviewed in order to develop improved cathodic protection and sinker systems. Based on the results of the design review, the mooring should be overhauled and necessary design changes incorporated. In addition, the installed Di-Lok chain should be replaced with stud link chain, and the buoy's hawse pipe should be fitted with a rubbing casting, or preferably, replaced with a tension bar type buoy.

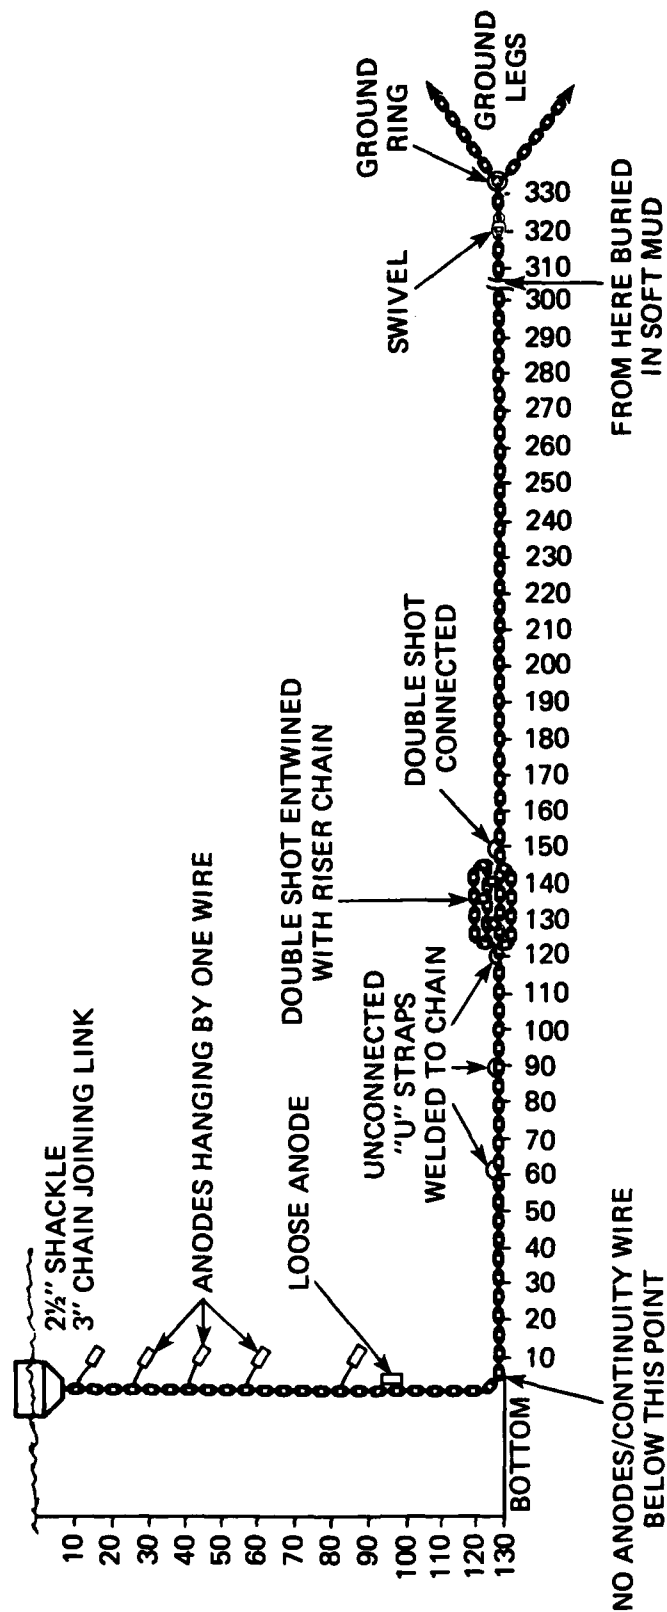
Figure A-111-1. South Bow Mooring Sketch, After Removal of Twenty Links
(Not to Scale)

1.3.2 Chain Assembly. The riser chain and visible portions of the ground legs showed little signs of wear or corrosion, and all sample-link wire diameters were well within tolerance. However, compared to the rest of the chain assembly, the 2-1/2" shackle connecting the riser to the buoy was undersized and could possibly fail under peak loads.

1.3.4 Cathodic Protection System. The cathodic protection system was unsatisfactory and in need of repair. Most anodes were either missing or loose, and below 130' from the buoy, there was no evidence that anodes or wire rope continuity cable were ever installed.

1.4 Conclusions and Recommendations. The southern bow mooring is considered to be in satisfactory condition for fleet usage, but the temporary buoy should be replaced with a permanent fleet mooring buoy. In addition, the apparently undersized and unnecessary 2-1/2" shackle, which connected the riser chain to the buoy via a 3" detachable link, should be removed.

The cathodic protection system should be overhauled and replaced. Moreover, a review of the design of the mooring should be undertaken to determine whether the double shot sinker chain is actually required or whether another type clump system would be more advantageous. At the completion of this design review, the mooring should be removed, overhauled, design changes incorporated, and the Di-Lok chain replaced with stud link.

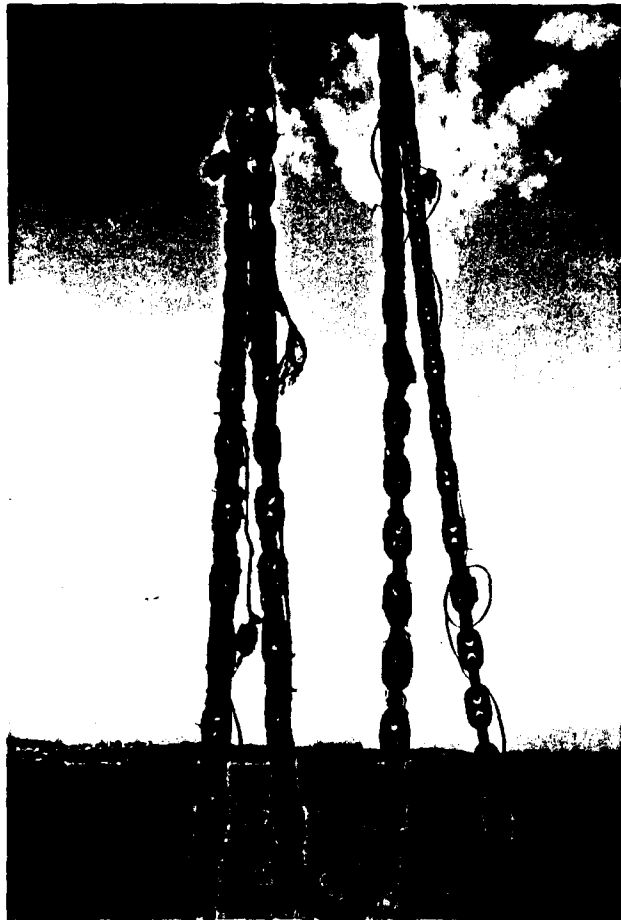
Figure C-2. Northern mooring riser chain being lifted at two points by the YD's crane. Note disconnected anodes and loose wire rope continuity cable.

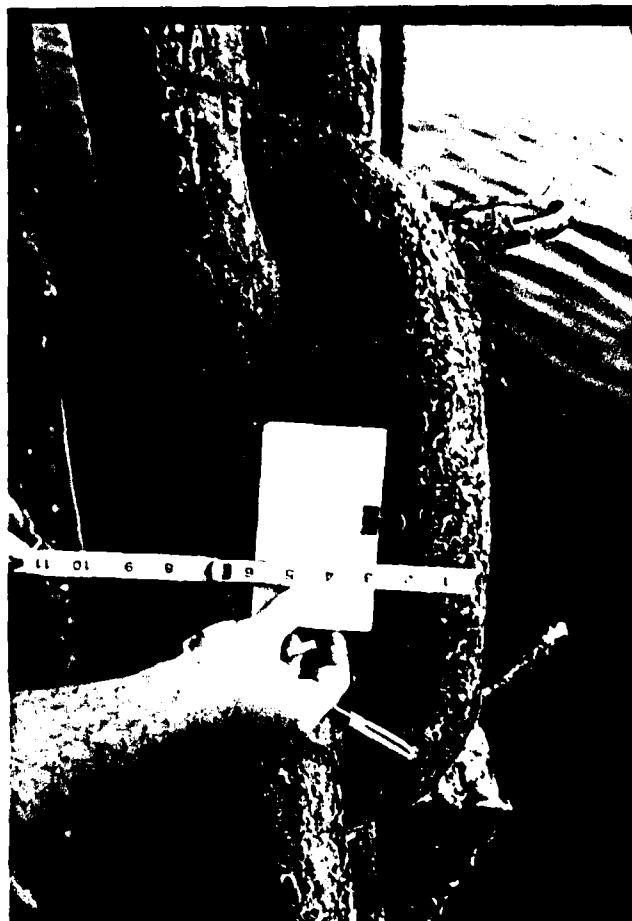
Figure C-4. Southern mooring link #92. Note anode attachment brackets welded to the link and anode hanging by the continuity cable.

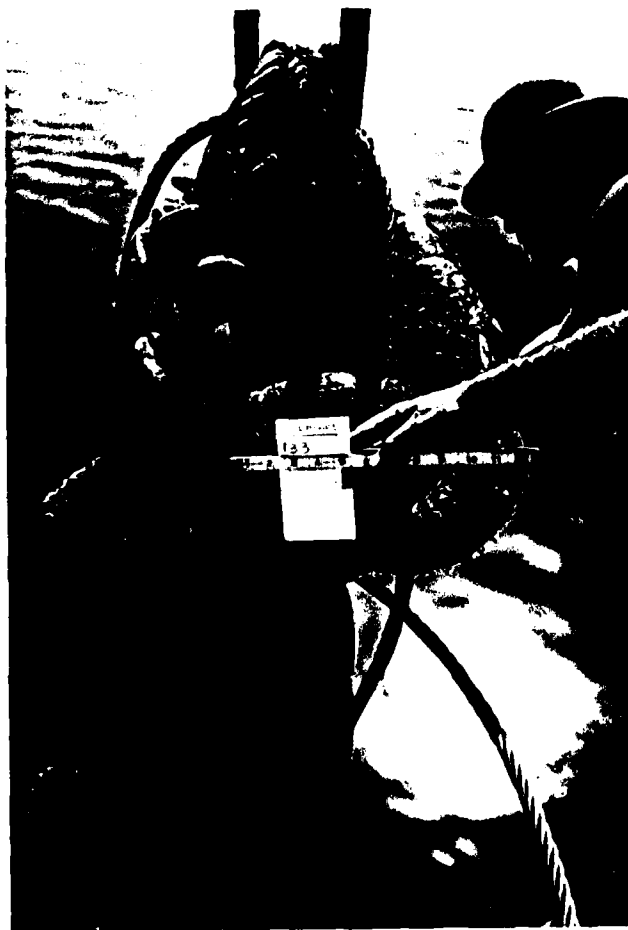
Figure C-5. Southern mooring link #133. "U" strap welded link with old navigation buoy connecting wire attached.
